‘Oftobak’

Sanitation facilities

(Caritas Switzerland)

1. Executive Summary

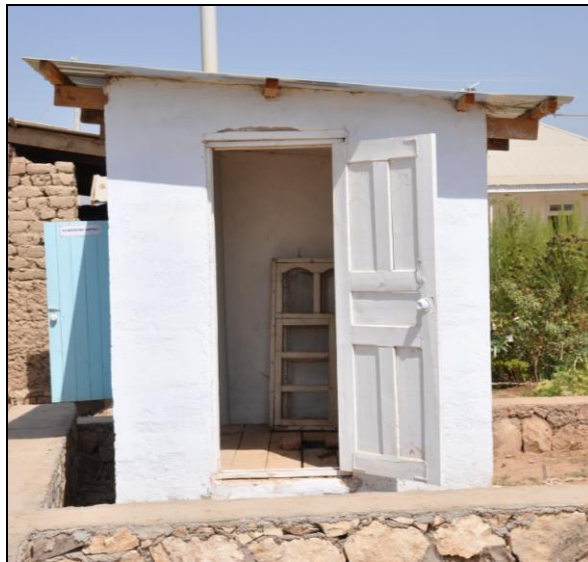
4.3. The Caritas sanitation facility is constructed of a 0.07m concrete lined pit, covered with a concrete slab with a brick construction outhouse. There is no lining at the bottom of the pit. There is a plastic pipe air vent from the pit through the roof of the facility to the outside.. (See photo front page)

b. Caritas Design: The water table level is 1.70m, 30cm deeper in the Caritas sanitation facility. The difference would imply that seepage is from the bottom of the sanitation pit and not through the concrete lining. The concrete lining is 7cm thick and is acting as a water barrier.

6.2. The use of concrete lining provides better protection for infiltration. The foot of the pit could be lined with a waterproof concrete. The adding of a detergent to the mix means that the less water is required to produce the cement. Therefore, when it dries the cement has a higher density and a lower porosity value. The foot of the pit should have been lined with concrete, possibly 20cm thick to prevent upwards seepage of groundwater.

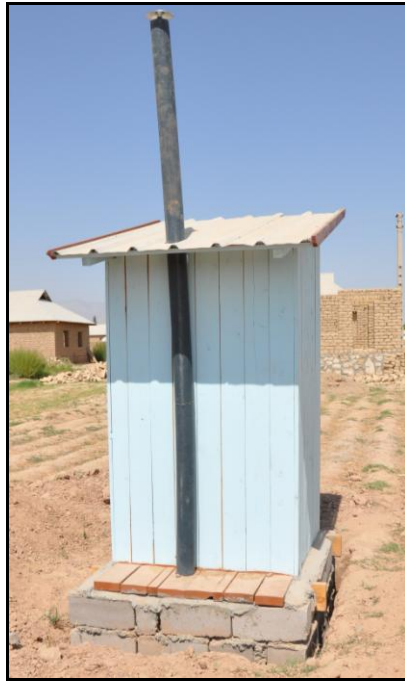
4.6. The adjacent sanitation facility constructed by Save the Children was also flooded, but to a higher depth of 1.40m. The Save the Children design used porous cement blocks to line the pit.

Photo 1: Save the Children Sanitation Block made of timber frame /porous concrete blocks

4.7 The Save the Children sanitation facility is made of porous breeze block and a wood frame outhouse.

a. Save the Children Design: the porous breeze block design of Save the Children has become saturated and that water is seeping through the pit lining. This has resulted in the reported ground water level of 1.40m deep.

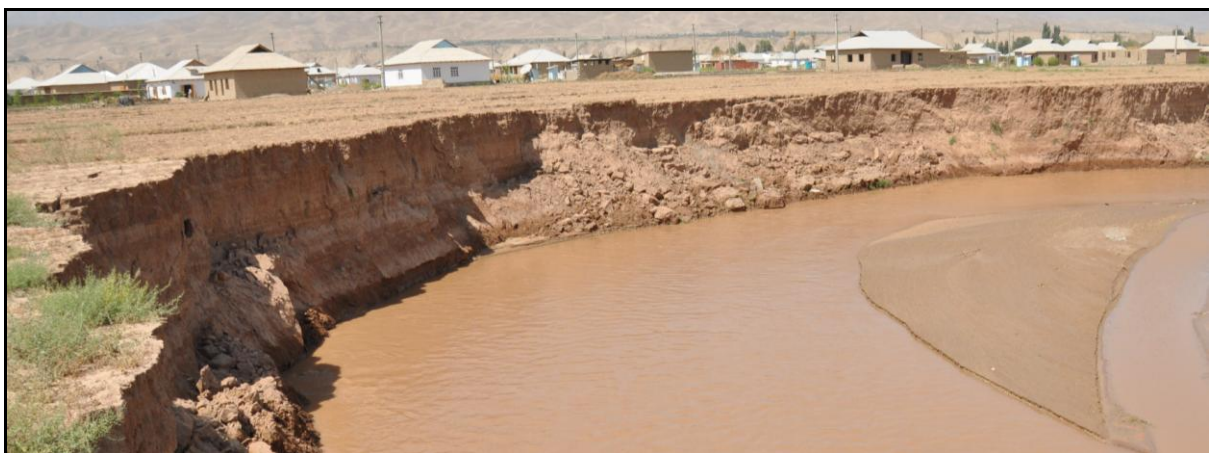
4.9 The soil profile appears to be one solid strata of loess soil as determined by the river bank profile. (See photo 2)

4.10 The river is currently (late summer) at low flow. There was evidence of mass erosion on the apex of the meander towards the settlement. The river is approx 8m below the flood plain. It was reported that the river rose to within 20cm of the floodplain level during heavy rains of April. (i.e. time of Kulyob disaster).

Photo 2: Mass River Bank Erosion 100m from Settlement / Solid Loess Strata

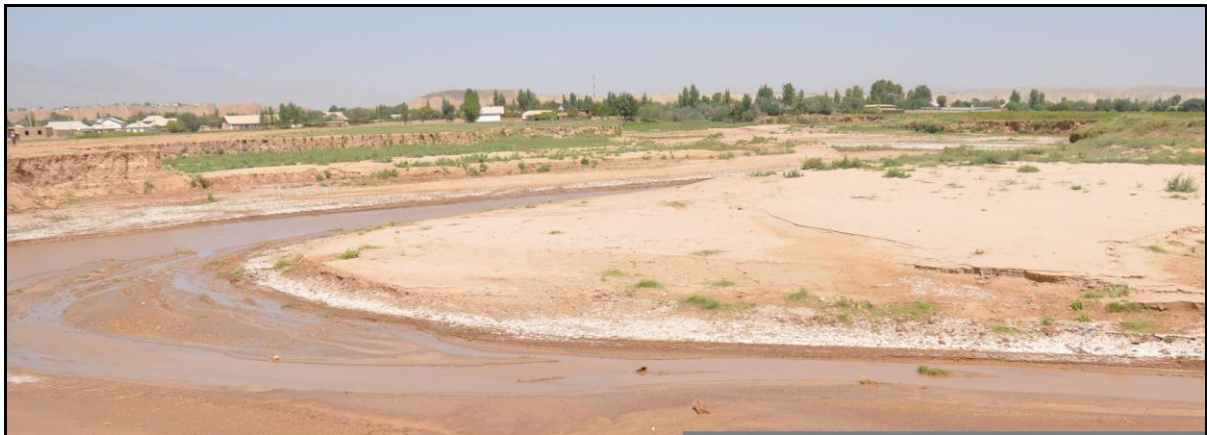
4.11 There was evidence of salt deposits along the edge of the river upto half a meter above the current river water level.

Photo 3: Salt Deposits on the River Bank

5.6. There was evidence of dried salt deposits on the soil surface, this will impact on the concrete lining and will speed up the deterioration process over time.

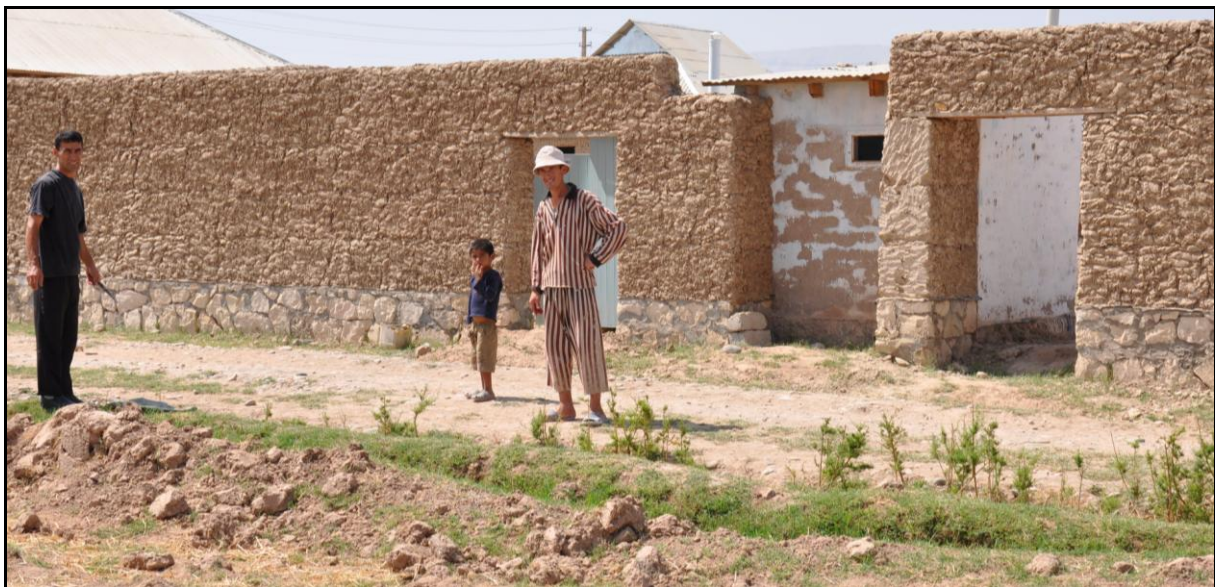
4.12 There is a 0.5.m deep drainage channel 10m from the flooded sanitation pits. This runs parallel with river. The drainage channel is used as a source of water for washing clothes, watering the garden and livestock. It was reported that water for cooking and drinking was collected from the standpipes.

Photo 4: Hassam stood alongside the 1.5m deep drainage channel used for washing and watering

It is believed due to the 1m head difference between the bottom of the drainage ditch and the water table, there is minimal risk of contamination of the drainage ditch as water will not seep upwards.

6.3 The risk to the drainage channel should be monitored to see if there is bubbling in the channel to indicate upward seepage.
