# ‘Oftobak’

## Sanitation facilities

(Caritas Switzerland)

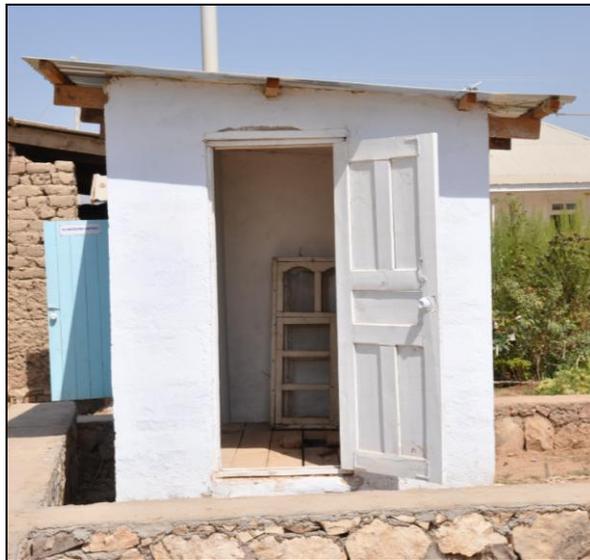
4.3. The Caritas sanitation facility is constructed of a 0.07m concrete lined pit, covered with a concrete slab with a brick construction outhouse. There is no lining at the bottom of the pit. There is a plastic pipe air vent from the pit through the roof of the facility to the outside.. (See photo front page)

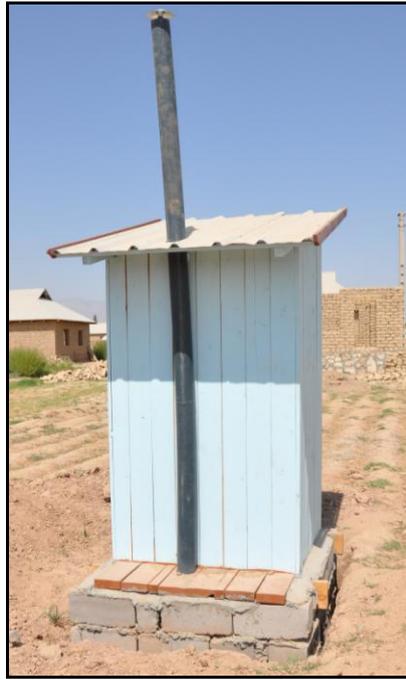
4.6. The adjacent sanitation facility constructed by Save the Children was also flooded, but to a higher depth of 1.40m. The Save the Children design used porous cement blocks to line the pit.

Photo 1: Save the Children Sanitation Block made of timber frame /porous concrete blocks

4.7 The Save the Children sanitation facility is made of porous breeze block and a wood frame outhouse.

a. Save the Children Design: the porous breeze block design of Save the Children has become saturated and that water is seeping through the pit lining. This has resulted in the reported ground water level of 1.40m deep.

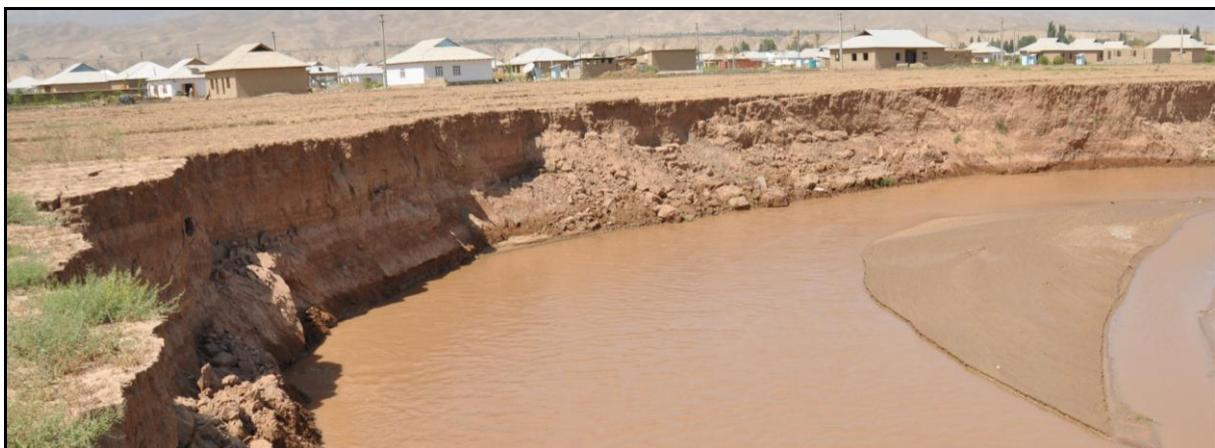
4.9 The soil profile appears to be one solid strata of loess soil as determined by the river bank profile. (See photo 2)

4.10 The river is currently (late summer) at low flow. There was evidence of mass erosion on the apex of the meander towards the settlement. The river is approx 8m below the flood plain. It was reported that the river rose to within 20cm of the floodplain level during heavy rains of April. (i.e. time of Kulyob disaster).

Photo 2: Mass River Bank Erosion 100m from Settlement / Solid Loess Strata

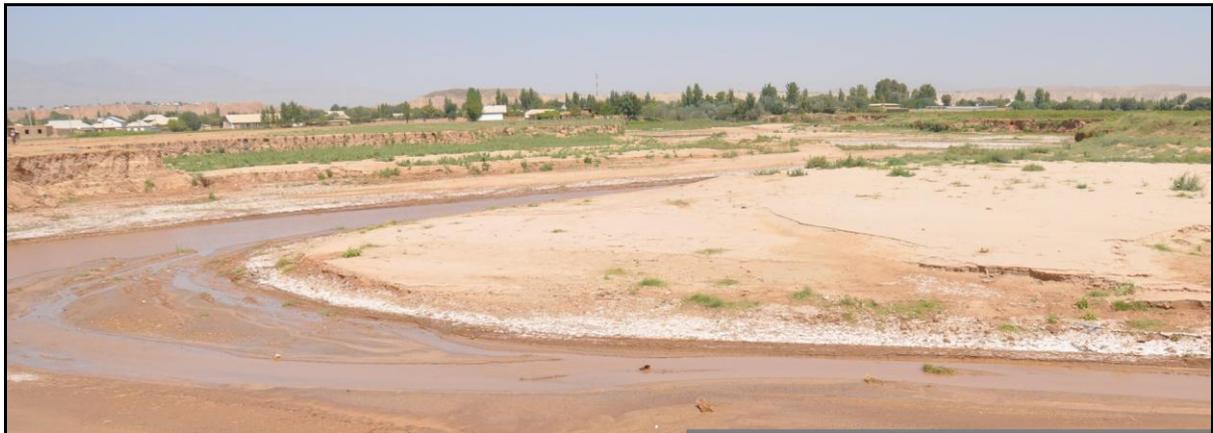
4.11 There was evidence of salt deposits along the edge of the river upto half a meter above the current river water level.

Photo 3: Salt Deposits on the River Bank

5.6. There was evidence of dried salt deposits on the soil surface, this will impact on the concrete lining and will speed up the deterioration process over time.

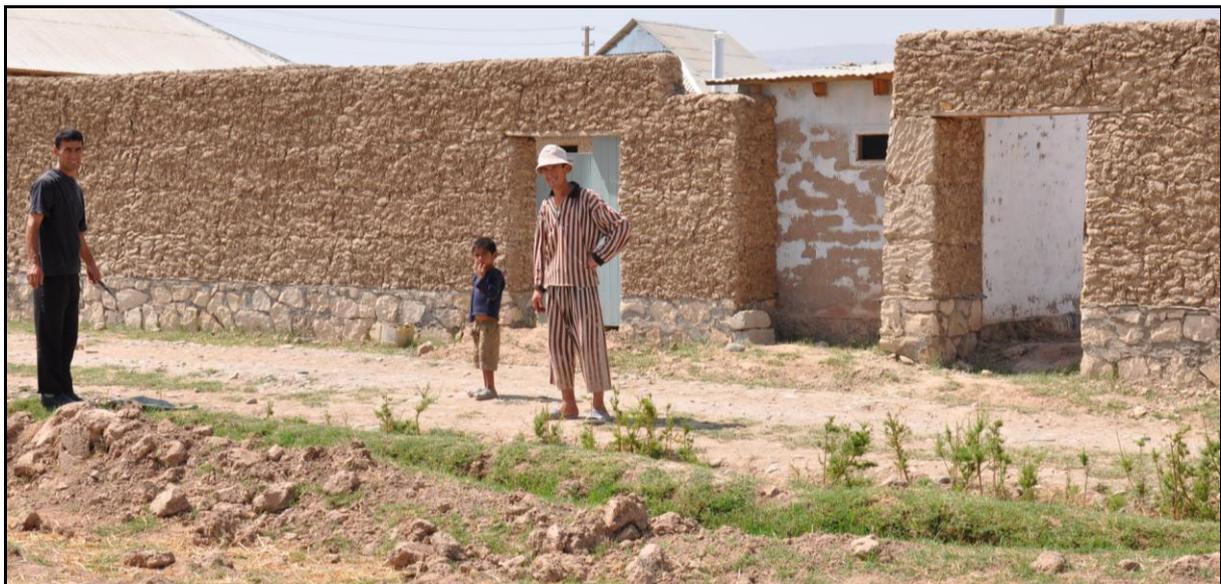
4.12 There is a 0.5.m deep drainage channel 10m from the flooded sanitation pits. This runs parallel with river. The drainage channel is used as a source of water for washing clothes, watering the garden and livestock. It was reported that water for cooking and drinking was collected from the standpipes.

Photo 4: Hassam stood alongside the 1.5m deep drainage channel used for washing and watering

6.3 The risk to the drainage channel should be monitored to see if there is bubbling in the channel to indicate upward seepage.
