Mudflows in Aini Jamoat (Khuroson District) in Spring 2009

Short geological report

Draft version June 29th, 2009

Author: Felix Bussmann, CAMP Kuhiston

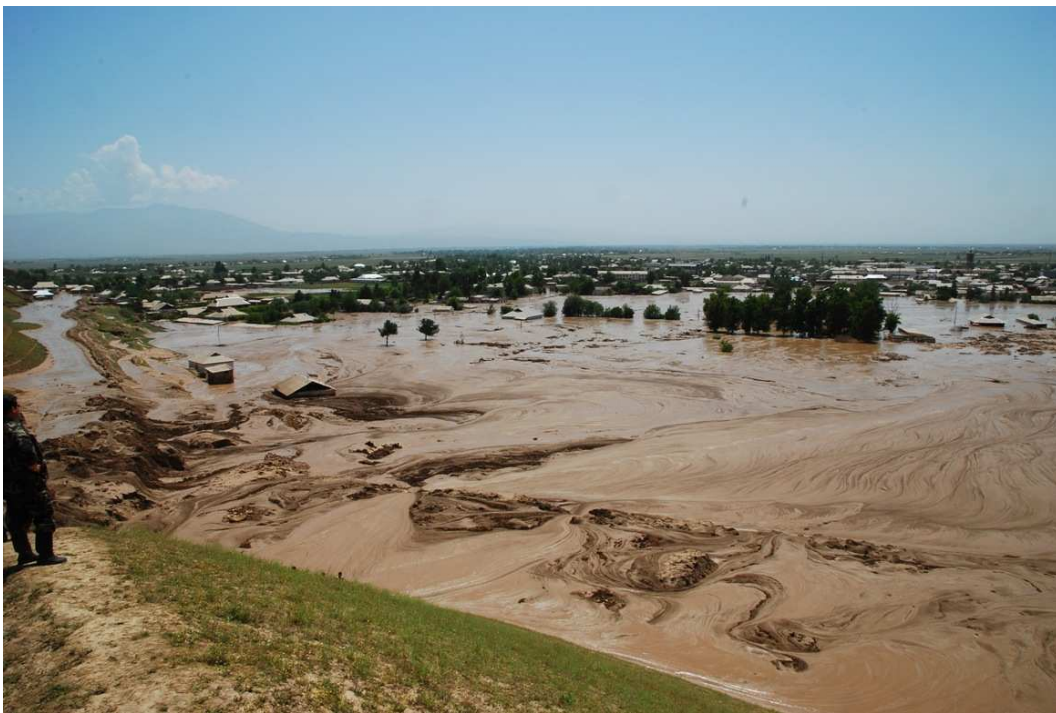
Figure 1: Uyali after second mudflow event on May 15th, 2009.

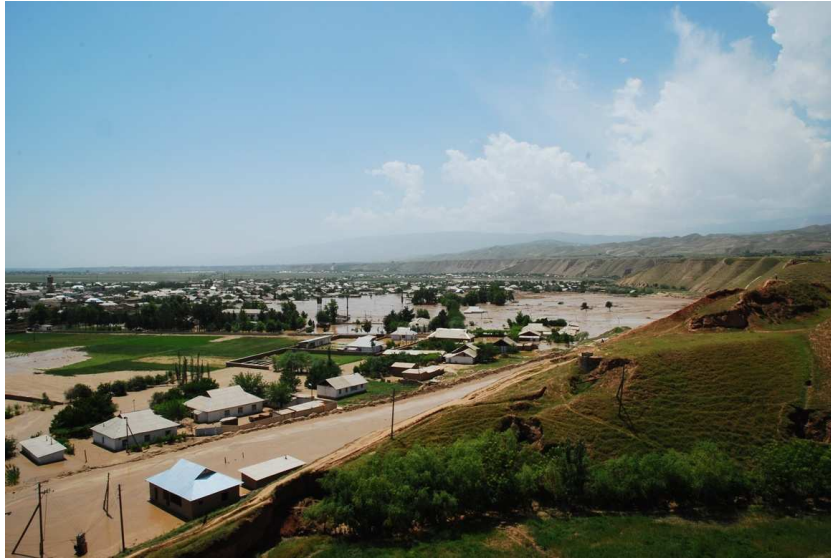
Figure 2: View from the northern tip of Uyali town towards southwest. The topographical step that separates the mudflow affected towns from the agricultural plateau is clearly visible. Moreover, the deposits of the second mudflow of May 14th 2009 are easily recognizable on the picture. Picture taken on May 15th 2009.

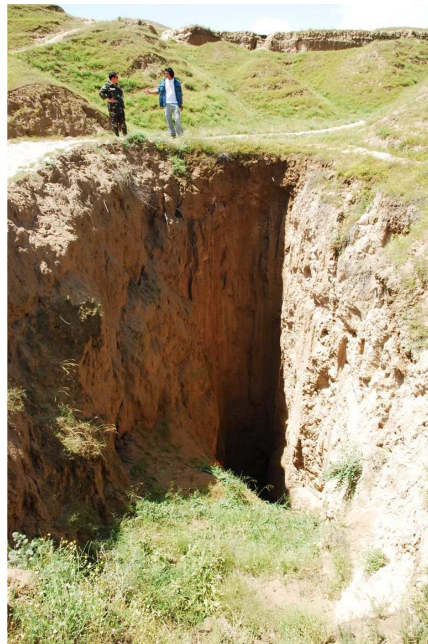
The loess deposits above the affected towns exhibit the whole range of loess-typical erosion features pointing towards ongoing and highly active erosion processes. The villages are located at the end of a deeply incised erosion channel, through which the devastating mudflows were channelled towards the populated area. Similar channels can be found along the whole loess plateau towards the north and the south, often reaching considerable size, both, in width and depth. Furthermore, so-called pseudo-carstic features as crevasses and funnels are very common and contribute to the ongoing erosion of the soil by facilitating the channelled inflow of surface runoff into the subsurface (Fig. 3).

Figure 3: Pseudo-carstic crevasse above Uyali. Such erosion features are typical for loess deposits and allow the infiltration of surface runoff into the subsurface. Picture taken on May 15th 2009.

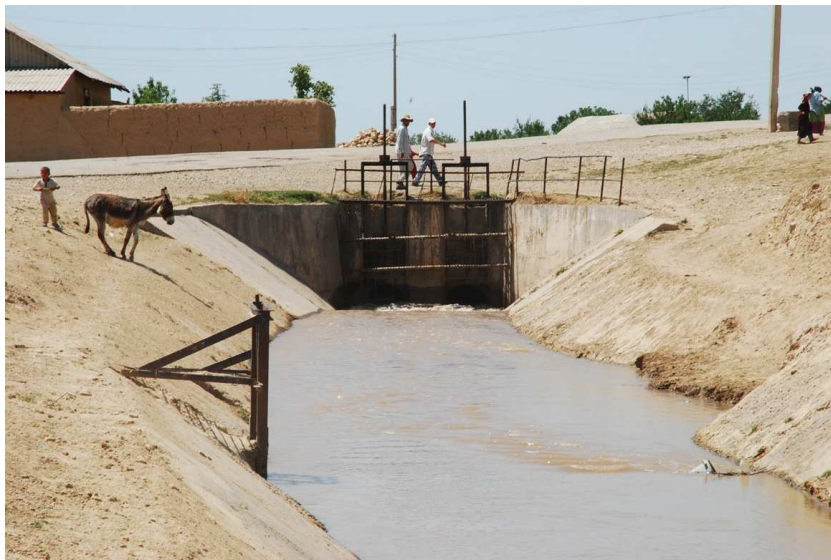
The intensive agricultural activity to the west of Uyali requests large amounts of water that are provided by a Sovjet-time irrigation system that was reportedly built in 1972. As visible on the overview picture in the Annex, an open irrigation channel runs in N-S direction above the agricultural fields that were partly washed away by the mudflow events. Close to the mudflow source area, the water enters two pipes of 1 m diameter each that run underground for several hundred meters (Fig. 4). However, the capacity of the underground pipes is too small in comparison with the open channel what in combination with exceptional rainfall events can cause backwater and subsequently an overflow of irrigation water downhill towards the agricultural fields.

Figure 4: Open irrigation channel above the agricultural fields to the west of Uyali. Clearly visible is the beginning of the underground pipes that run several hundred meters downhill. Picture taken on June 17th.

According to villagers, it was the first time since the construction of the irrigation scheme in 1972 that the irrigation channels and pipes had not enough capacity to deal with the accumulating surface runoff. However, considering climate change and its associated accumulation of exceptional hydrological events, such runoff amounts might be observed more often in the future. It is thus advisable to hydrologically assess the existing irrigation scheme in order to come up with a convenient solution that inhibits the channel from overflowing.

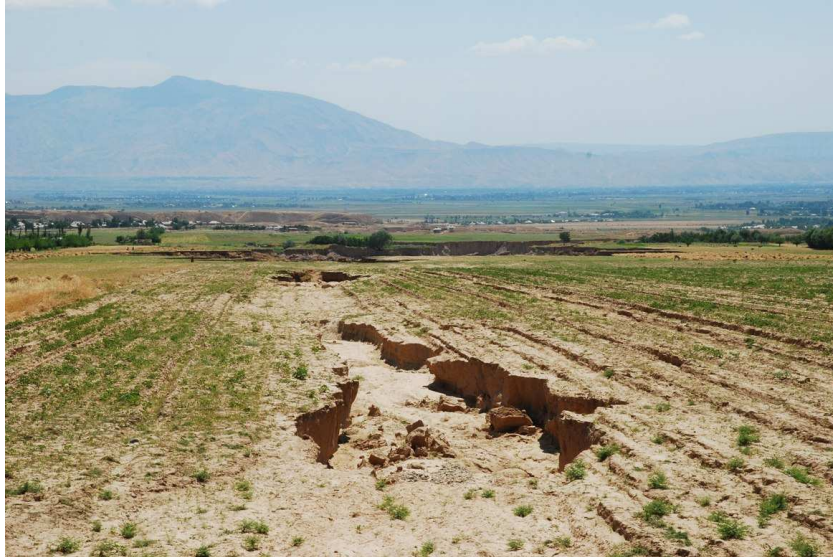
Heavy rainfalls on April 20th and May 14th led to extreme surface runoffs in the hills above the mudflow affected settlements. Thereby, the open irrigation channel was filled over its capacity limit, provoking an overflow of water towards the agricultural fields. Traces of the overflowing water in the agricultural fields confirm the high erosional capacity of the water that caused vast backwards erosion on the top end of the pre-existing mudflow channel (Fig. 5).

Figure 5: Flow indicators in the agricultural fields above Uyali. The open irrigation channel is situated approximately 100 m behind the camera position. View in flow direction towards the mudflow source area (washed away fields). Picture taken on June 17th.

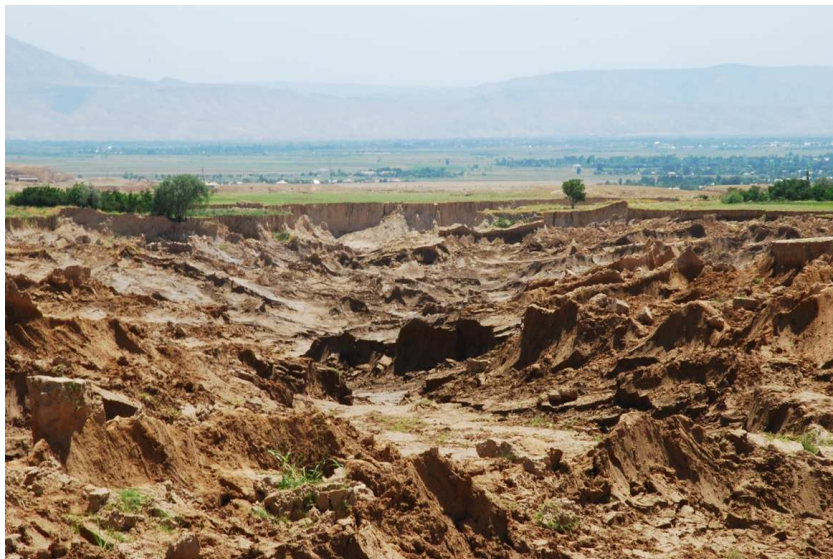
The heavy rainfall together with the overflowing irrigation water caused retrogressive erosion on the top end of the pre-existing mudflow channel (Fig. 6). Thereby, an area of approximately 500 m x 200 m of agricultural fields was washed away to a depth of often more than 8-10 m. This leads to the assumption that during the two mudflow events a minimum of 600'000-700'000 m³ of soil material have been displaced.

Figure 6: Mudflow source area. At least 600'000-700'000 m³ of loess soil have been washed away. View downslope towards the top end of the mudflow gully. Picture taken on June 17th.

Notably, the second mudflow event of May 14th had the same source area as the first event of April 20th, extending the area of washed-away agricultural fields further upslope. Causes and Triggers of both events are thus the same.
